Rapid Airfield Damage Recovery: Deployable Saw Technology Evaluation

Haley P. Bell and Jay Rowland

December 2017

Final report

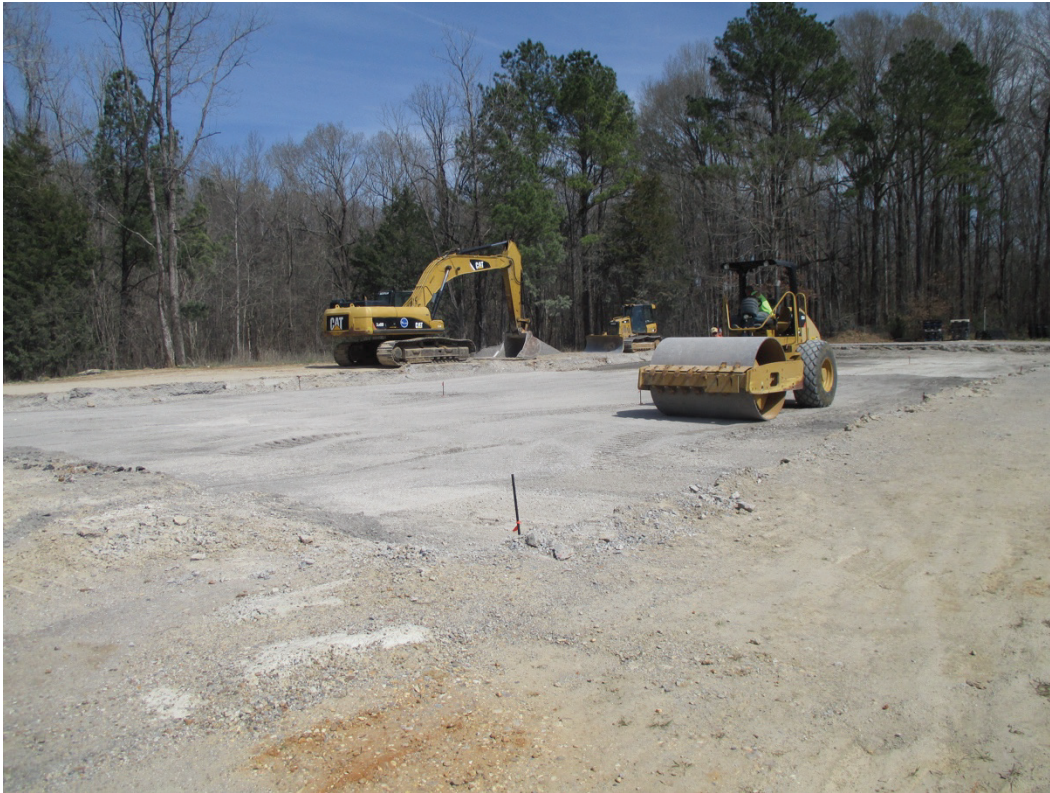
Figure 2. Compacting crushed limestone base material.

The existing subgrade, classified by the Unified Soil Classification System as a brown clay (CL), was graded prior to construction with a 0.4 percent cross-slope to allow for drainage. The base layer was placed over the subgrade and consisted of 6 in. of compacted #610 crushed limestone (ASTM C33/C33M-16) (ASTM International 2016a) under the 18-in.-thick PCC or 9 in. of compacted #610 crushed limestone (ASTM C33/C33M-16) under the 15-in.-thick PCC. The crushed limestone was compacted to a target of 95 percent modified Proctor maximum density. A Caterpillar CP-563 vibratory smooth drum roller was used for compaction (Figure 2).

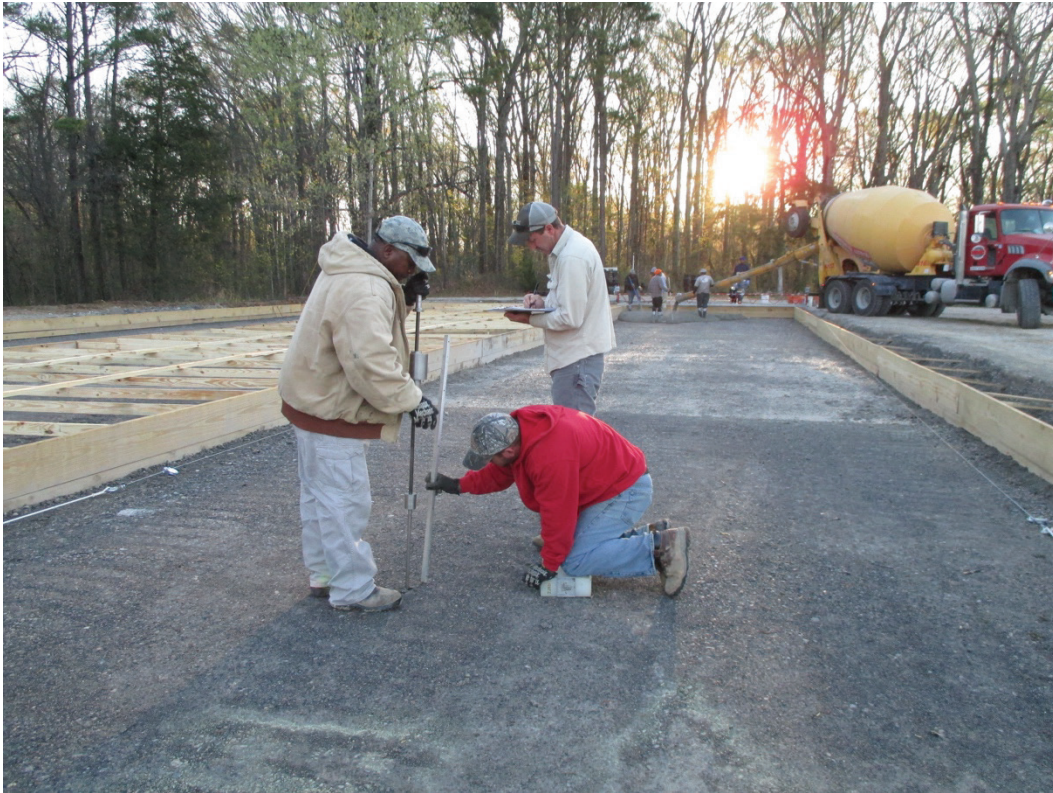
Figure 3. DCP testing.

The limestone base layer material was characterized during construction using the Troxler nuclear density gauge (ASTM D6938) (ASTM International 2017) and the dynamic cone penetrometer (DCP) (ASTM D6951) (ASTM International 2015). DCP testing is shown in Figure 3. Figure 4 shows the nuclear density gauge being used on the base material on the southeastern portion of the test section. DCP and nuclear density measurements were taken directly before each concrete placement.

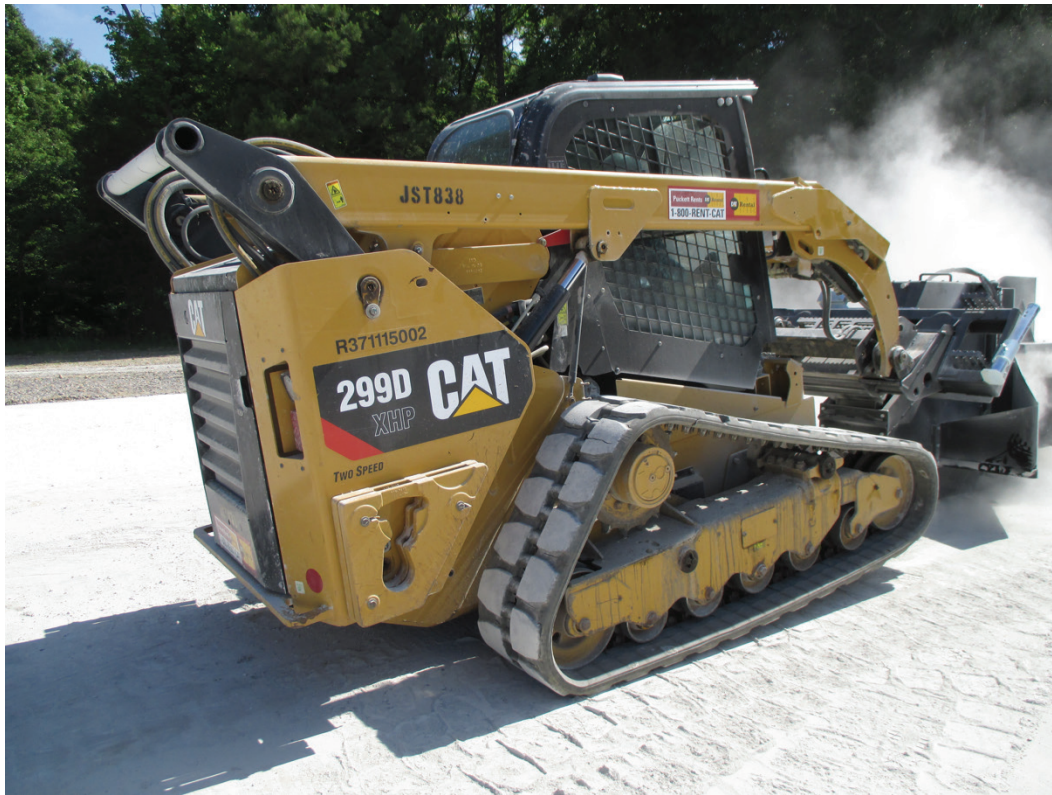
Figure 11. Caterpillar 299D XHP CTL.

Compact track loaders (CTL), or skid steers, are high-flow, rubber-tracked machines with quick disconnect fittings that are used for numerous tasks in the current ADR crater repair TTPs (Figure 11). The quick disconnect feature allows attachments to be rapidly switched without the use of tools. These multi-purpose machines are employed for many of the ADR processes, including rapidly cutting around the upheaval of bomb-damaged pavement (repair area boundaries) with wheel saw attachments, breaking pavement with the hammer attachment, removing debris with bucket attachments, screeding pelletized asphalt repair caps with the asphalt screed attachment, and clearing of dust and debris with the broom attachment.

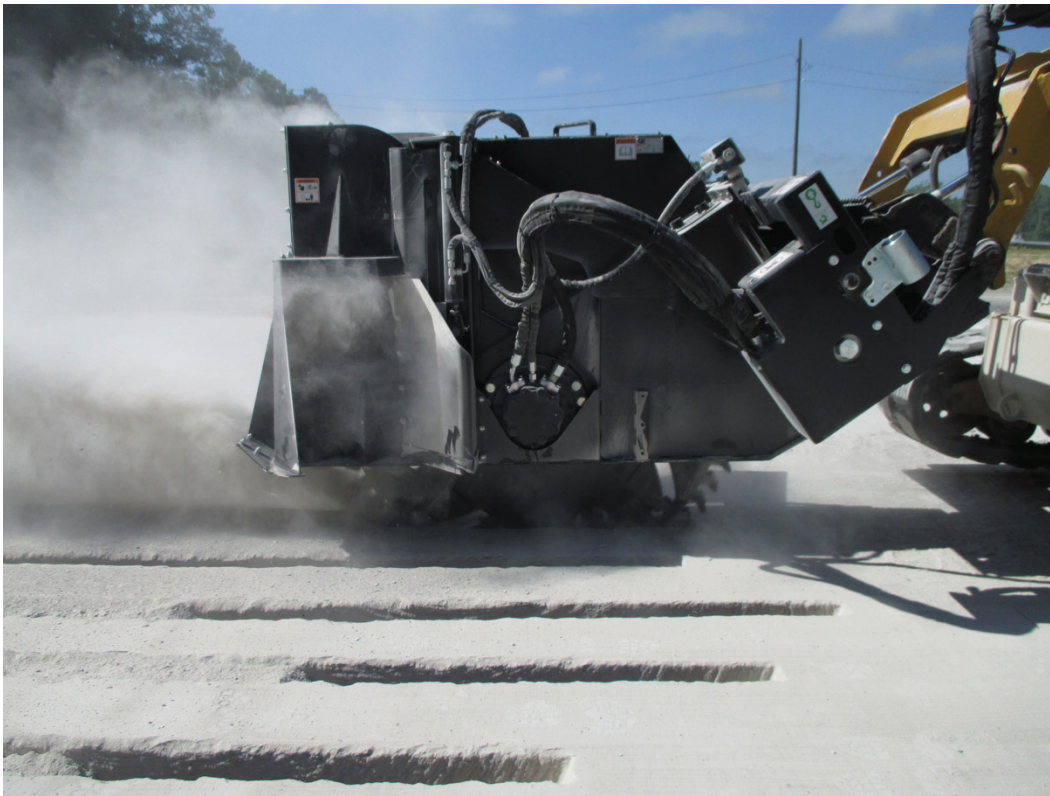
Figure 12. Caterpillar SW460B wheel saw attachment.

The Caterpillar CTLs are equipped to operate the Caterpillar SW45, SW360B, or SW460B (Figure 12) wheel saw attachments. These wheel saw attachments have 3-in.-wide blades that produce approximately 3.5-in.-wide cuts. The SW360B and SW460B models also have blade width options of 6 and 8 in., but the cuts are too wide for the purposes of the ADR program. The SW45, which Caterpillar has replaced with a SW345B model, has an 18-in.-maximum depth cut, while the SW360B and SW460B can produce 24-in.-maximum depth cuts. Figure 13 shows a CTL with the wheel saw attached before cutting. Specifications for the SW45, SW360B, and SW460B machines are shown in Table 4.

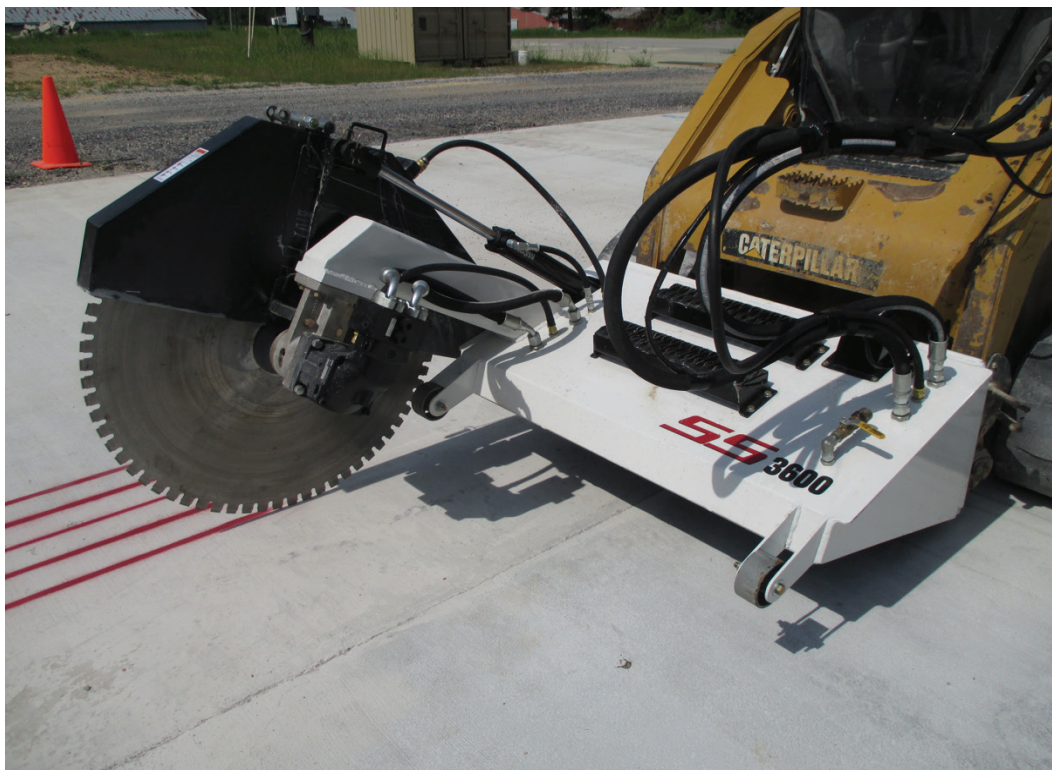
Figure 14. Cuts, Inc. SS3600 diamond blade saw attachment.

Cuts, Inc. developed two prototype diamond blade saw attachments (SS3600 and SS3600HF) that are compatible with the Caterpillar CTLs. Figure 14 shows the SS3600 attached to a CTL. For this evaluation, 36-, 42-, and 48-in.-diam diamond-tipped blades were used on the attachments. The diamond-tipped skid steer attachments require the use of an external water source to keep the blade from becoming overheated during operation.

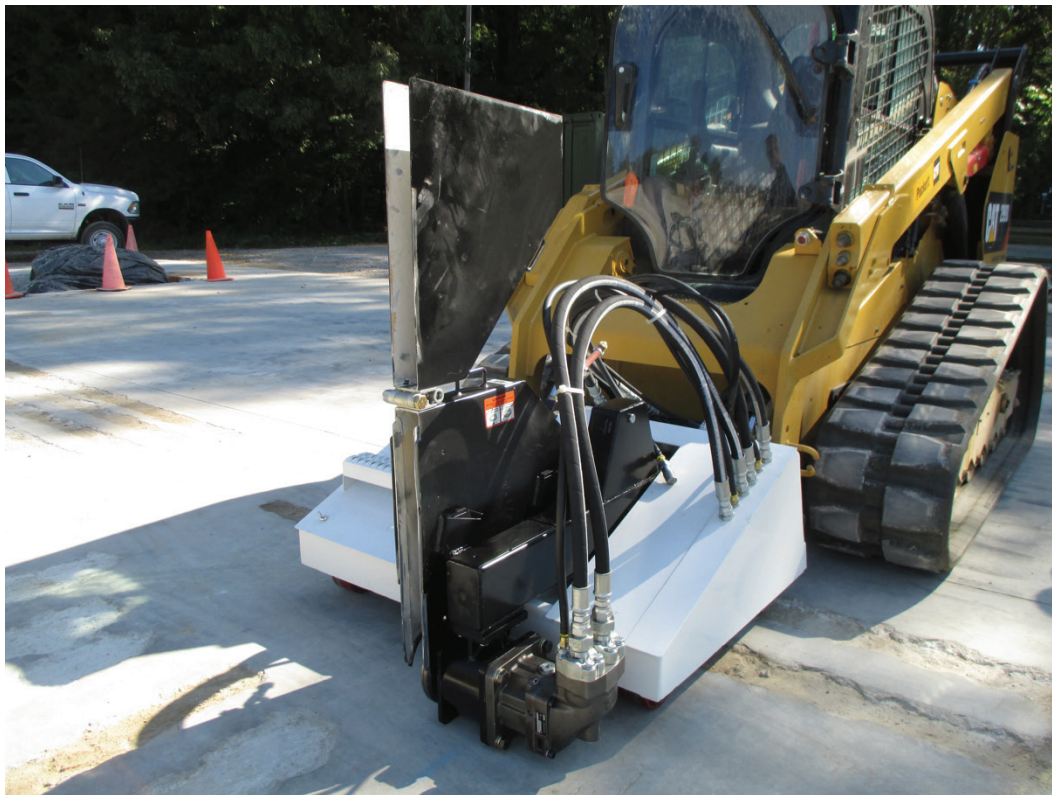
Figure 15. Cuts, Inc. SS4800HF diamond blade saw attachment without the blade.

After the initial testing with the SS3600 and SS3600HF attachments, Cuts, Inc. made some modifications and returned for further testing with the SS4800HF prototype unit. Some of the modifications included a larger, more powerful hydraulic motor, a redesign of the blade shaft, the relocation of the saw blade housing, and the addition of four wheels on the bottom of the unit. The wheels can be lifted and not used if necessary. Table 5 presents the specifications of the diamond blade attachments as measured in the field. The dimensions in the table are as if the blade is installed on the machine. The length and height dimensions are different when the blade is not on the machine, because the top half of the blade housing can be lifted for storage as shown with the SS4800HF in Figure 15.

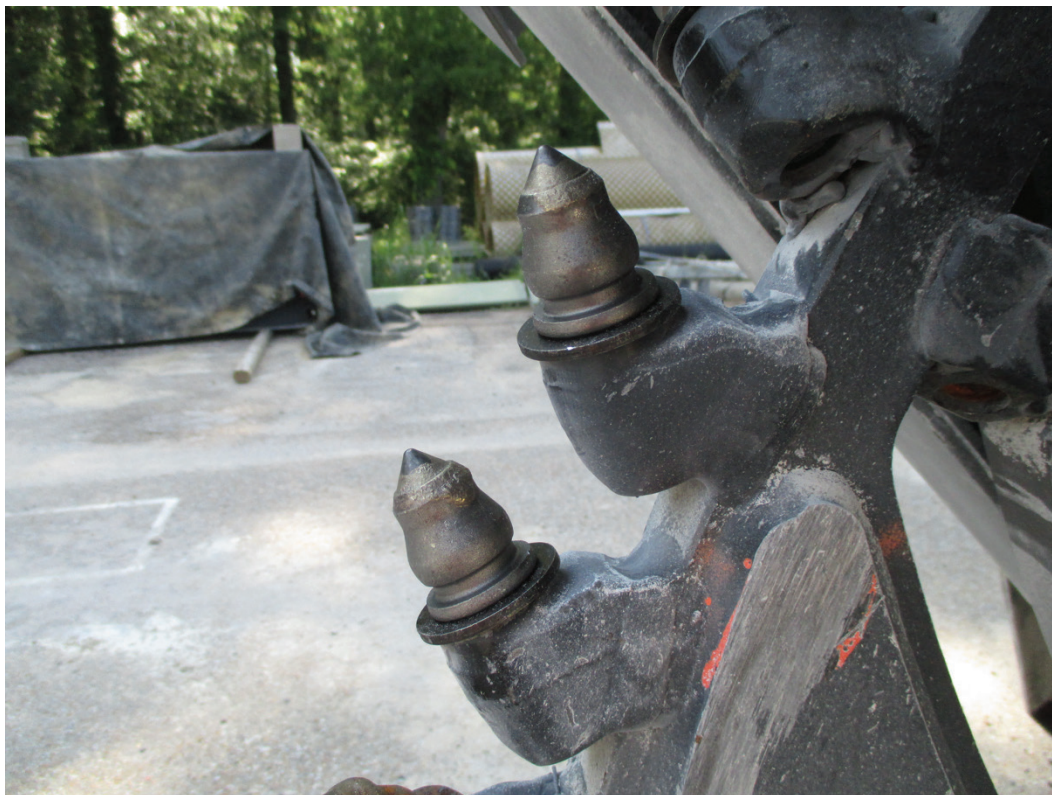
Figure 16. Prototype wheel saw tooth, Caterpillar 75148-1.

The Caterpillar 75148-1 prototype cutting tools (Figure 16) were designed for cutting concrete. The teeth are made of carbide tungsten and forged steel and consist of a 0.63-in.-diam carbide insert. The shank diameter is 0.78 in. The shank is the cylindrical shaft that is housed inside the wheel saw shoe.

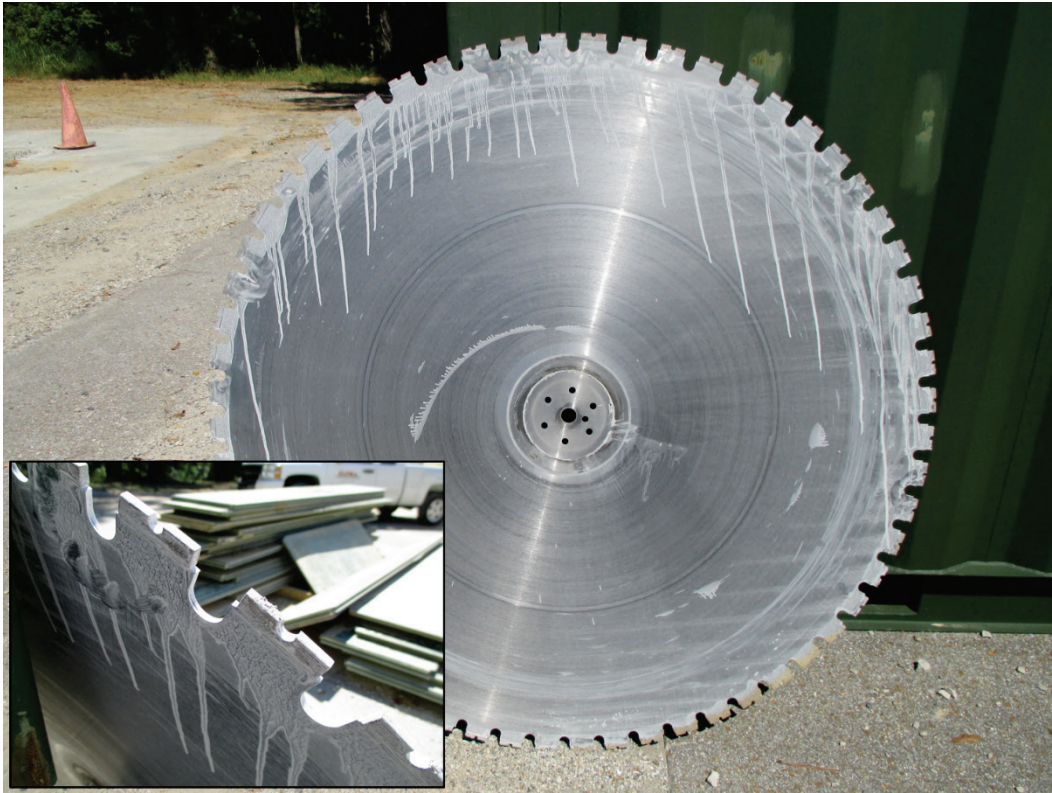
Figure 18. Diamond-tipped saw blade.

Diamond-tipped saw blades are made with a steel core (Figure 18). The diamond segments, which are welded to the core, are what is used to cut through the concrete. The depth of the diamond segments in this study were approximately 0.5 in. The blades are typically $\frac{1}{4}$ in. wide or less and can vary in diameter. For this study, the blades were about $\frac{3}{16}$ in. wide and 36, 42, and 48 in. in diameter.

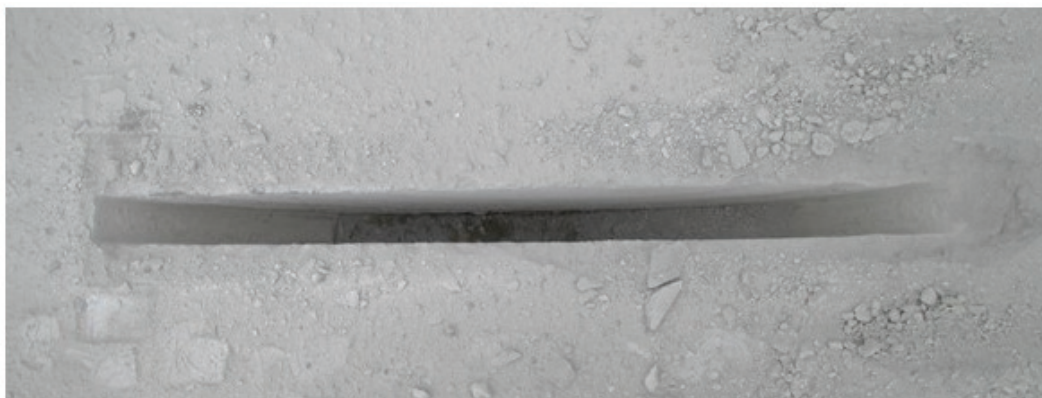
Figure 20. One plunge cut with the Caterpillar wheel saw attachment.

Two tests, Tests 9 and 10, were completed using the Caterpillar 299D XHP equipped with the SW360B and Kennametal RP15 teeth. Test 9 was conducted in the traditional manner - plunge full depth through the PCC, and then cut forward. Test 10 was completed using only plunge cuts; each of these cuts in this test consisted of three or four plunge cuts before the 10-ft-long cuts were complete. The two methods of cutting had essentially the same cutting rates, 1.02 versus 0.96 ft/min. The Caterpillar 299D XHP equipped with the SW360B and Kennametal RP15 teeth was able to meet the 1 ft/min saw-cutting rate goal. The downside of the plunge only cuts was that humps of PCC would sometimes remain in the cut line. This was due to the saw's circular shape (Figure 20) and the saw sitting back as it plunges through the PCC. It is difficult for the saw spotter or operator to line up the saw properly so that there is the correct amount of overlap between the plunge cuts. Too much overlap will result in a longer cut time. Too little overlap will result in humps of PCC remaining inside the cut.

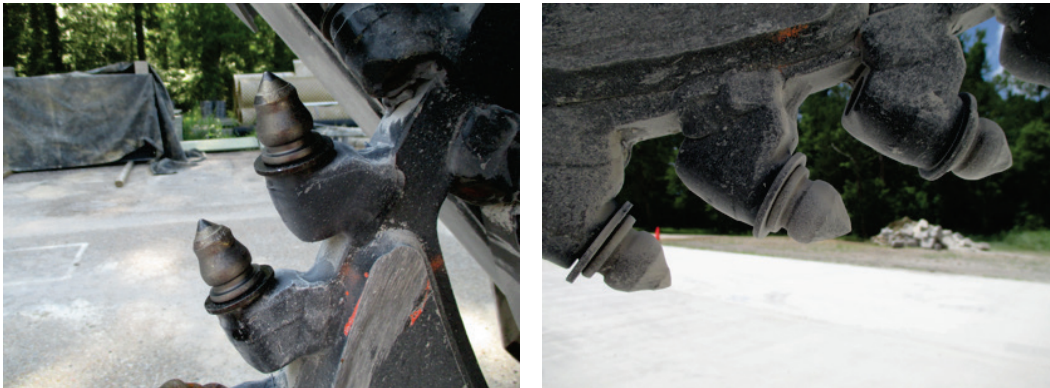
Figure 23. Caterpillar 75148-1 prototype cutting bits before cutting and after 102 ft of cutting.

The prototype Caterpillar 75148-1 teeth were tested on the Caterpillar SW460B with the 299D XHP skid steer. When comparing the Caterpillar teeth to the Kennametal teeth used on the same equipment duo, the rates were the same; however, the teeth wear was not. The Kennametal RP15 teeth could likely handle 1.5 times more linear feet of cutting before reaching 30 percent of wear on the cutting teeth. Figure 23 shows the Caterpillar 75148-1 prototype cutting bits before cutting and after cutting 102 ft of 18-in.-thick PCC. The teeth were worn approximately 18 percent after 102 ft of cutting.

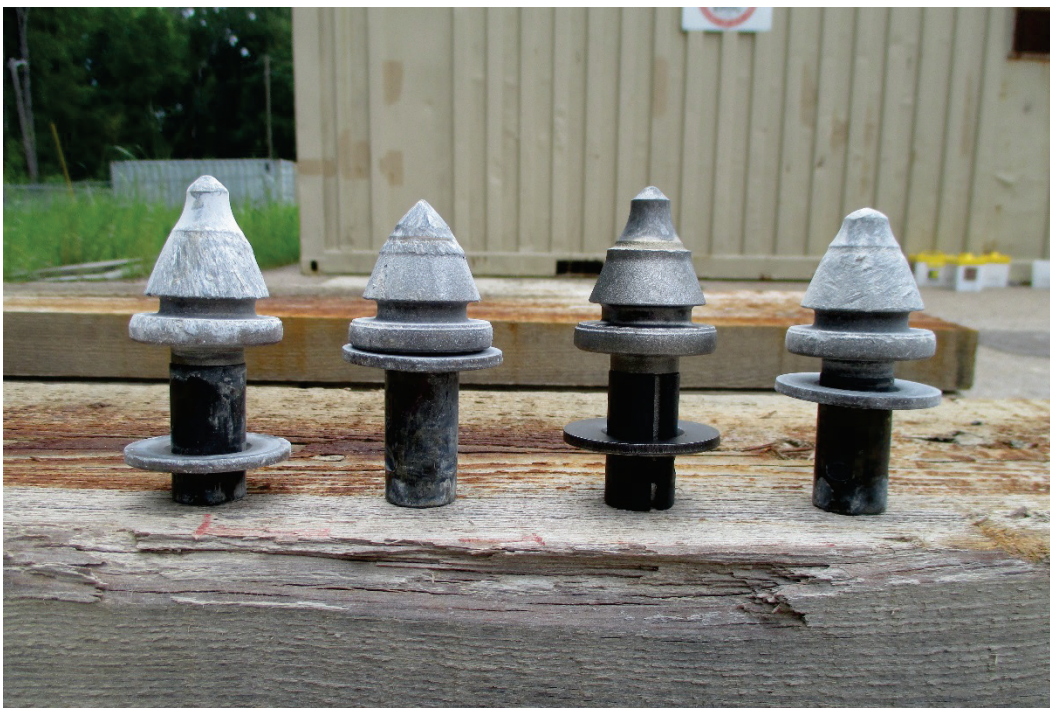
Figure 24. Inconsistent wear of Kennametal RP15 teeth on Caterpillar SW360B wheel saw.

Table 8 also shows that the Caterpillar SW460B wheel saw would barely be able to efficiently complete the required 340 ft of linear saw cutting in 18-in.-thick limestone-mixed PCC for small craters without having to stop and replace worn teeth. The Kennametal RP15 teeth are more durable on the Caterpillar SW360B and SW45 wheel saws and would not require replacing teeth before the required 340 ft of cutting is complete. Figure 24 shows how uneven the teeth wear can be on the wheel saws. The third cutting bit from the left is new. The other teeth, used on the same Caterpillar SW360B wheel saw, cut approximately 100 ft of 18-in.-thick PCC at the same time.

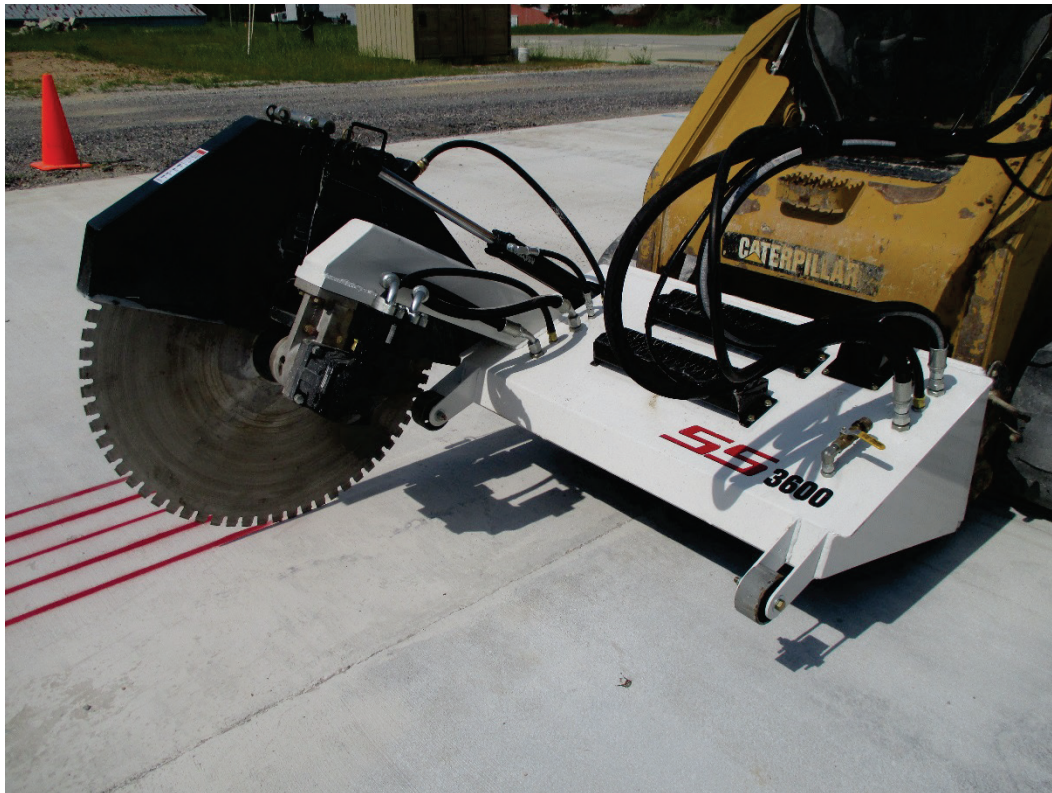
Figure 25. SS3600 diamond blade attachment mounted on a Caterpillar 279C XPS CTL.

The first assessment, Test 4, for this suite of testing included a 36-in.-diam diamond blade (SS3600) attached to a Caterpillar 279C XPS CTL, as shown in Figure 25. The attachment with the 36-in.-diam blade allowed for a 15- to 16-in.-depth cut. The saw blade was approximately 3/16 in. wide. For increased stability, Cuts, Inc. recommends a 1/4-in.-wide saw blade for concrete cutting applications. A wider blade produces a straighter cut line; however, production is lost.

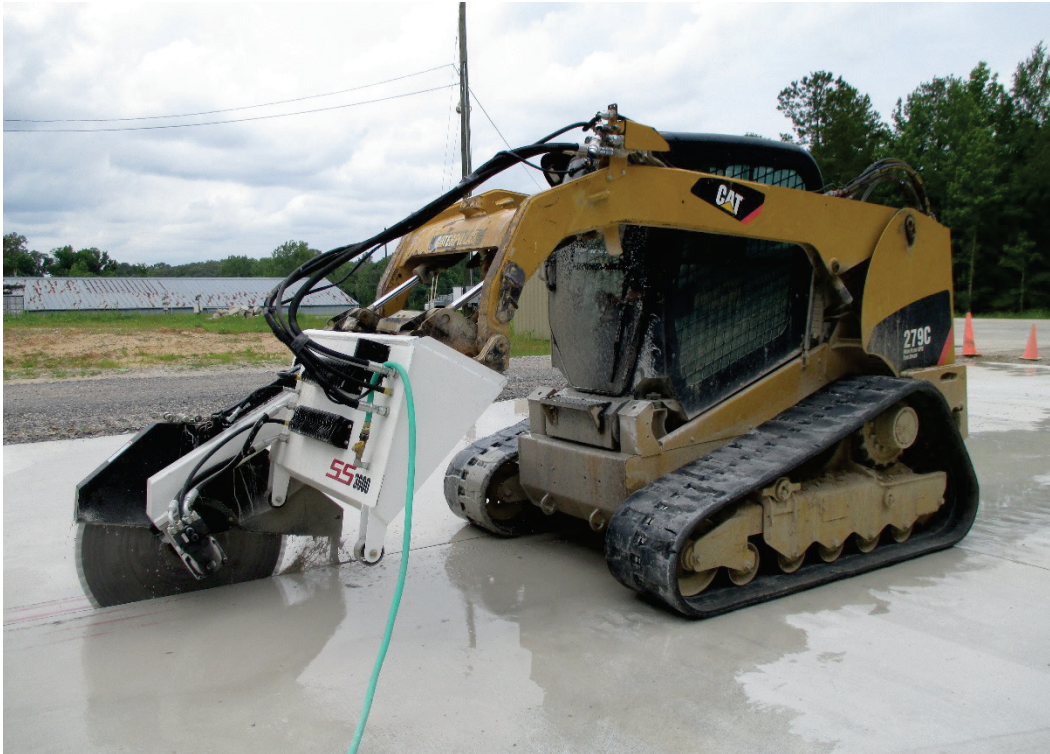
Figure 26. Sludge splattering the windshield of the Caterpillar 279C XPS CTL during cutting.

The saw-cutting times using the 36-in.-diam blade through the 15-in.-thick PCC ranged from 1.60 to 1.67 ft/min and averaged 1.64 ft/min. The average precutting time over the 11.5- to 13-ft-long cuts was 1 min 21 sec. The setup of the attachment allowed for a large amount of concrete sludge to splatter on the windshield of the CTL during cutting (Figure 26). This could potentially hinder the sight of the CTL operator, particularly if the windshield wiper is not operational.

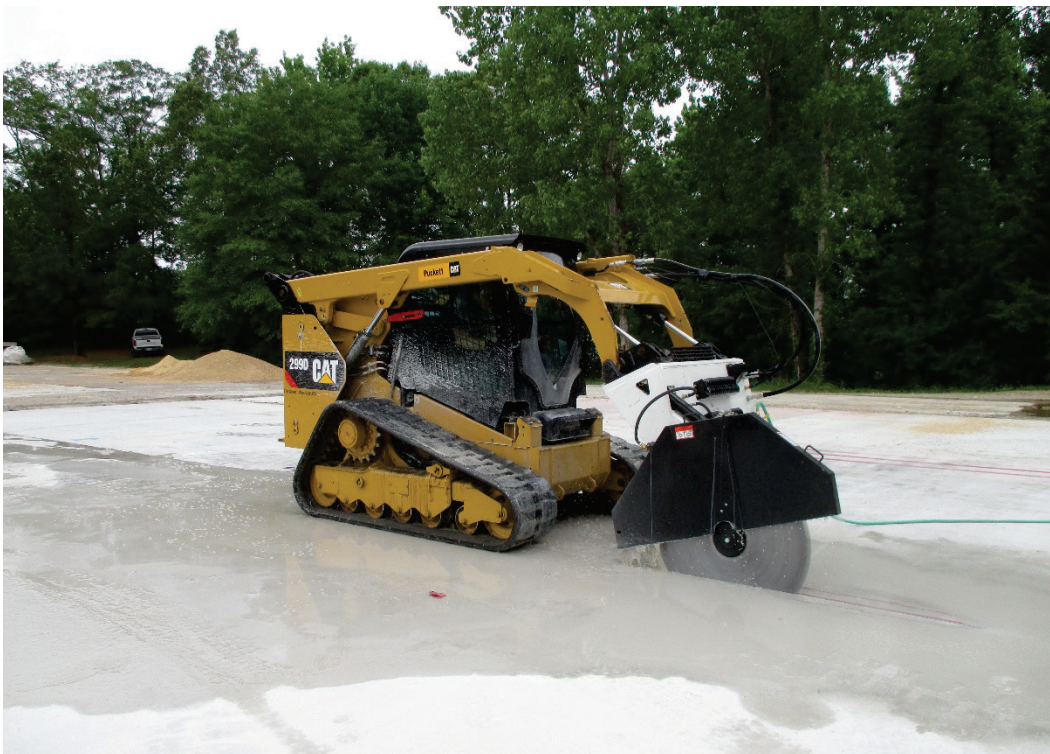
Figure 27. SS3600 diamond blade attachment with a 36-in.-diam blade on a Caterpillar 299D XPS CTL.

Test 5 used the same blade and attachment on a Caterpillar 299D XPS CTL in 15-in.-thick PCC, as shown in Figure 27. Two cuts were made using this equipment setup. Each cut was approximately 11.5 ft long.

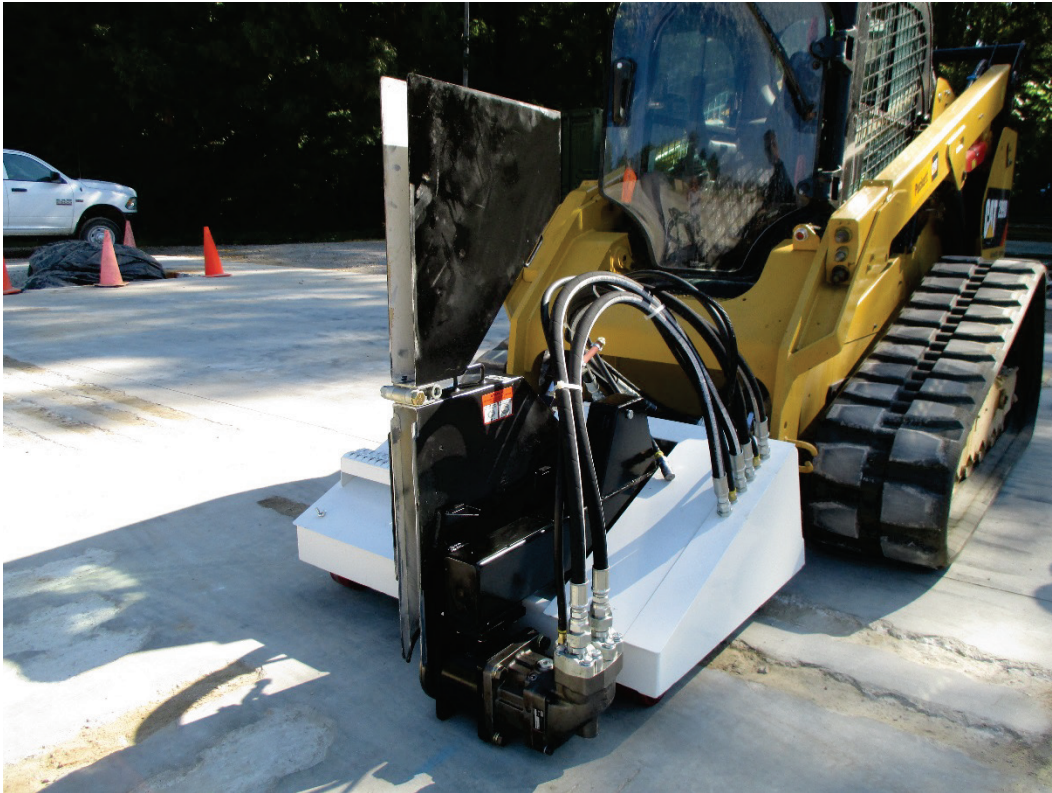
Figure 30. SS4800HF diamond-tipped saw blade attachment.

The purpose of this second round of testing (Tests 11 and 12) was to evaluate the diamond-tipped saw blade attachment modified by Cuts, Inc. The modified unit, labeled as SS4800HF, is shown in Figure 30. The modifications were based mainly on the concrete saw-cutting testing conducted at ERDC in June 2016 (Evaluation #1). Some of the modifications to the attachment included a larger, more powerful hydraulic motor, the addition of four wheels on the bottom of the unit, a redesign of the blade shaft, and the relocation of the saw blade housing. A 42-in.-diam saw blade on the modified attachment has the ability to cut 20 to 21 in. deep. Cuts, Inc. also used an external 100-gal water tank during this test to approximate how much water is used when cutting. All cuts were made using a Caterpillar 299D XPS CTL as the prime mover, operated in high flow.

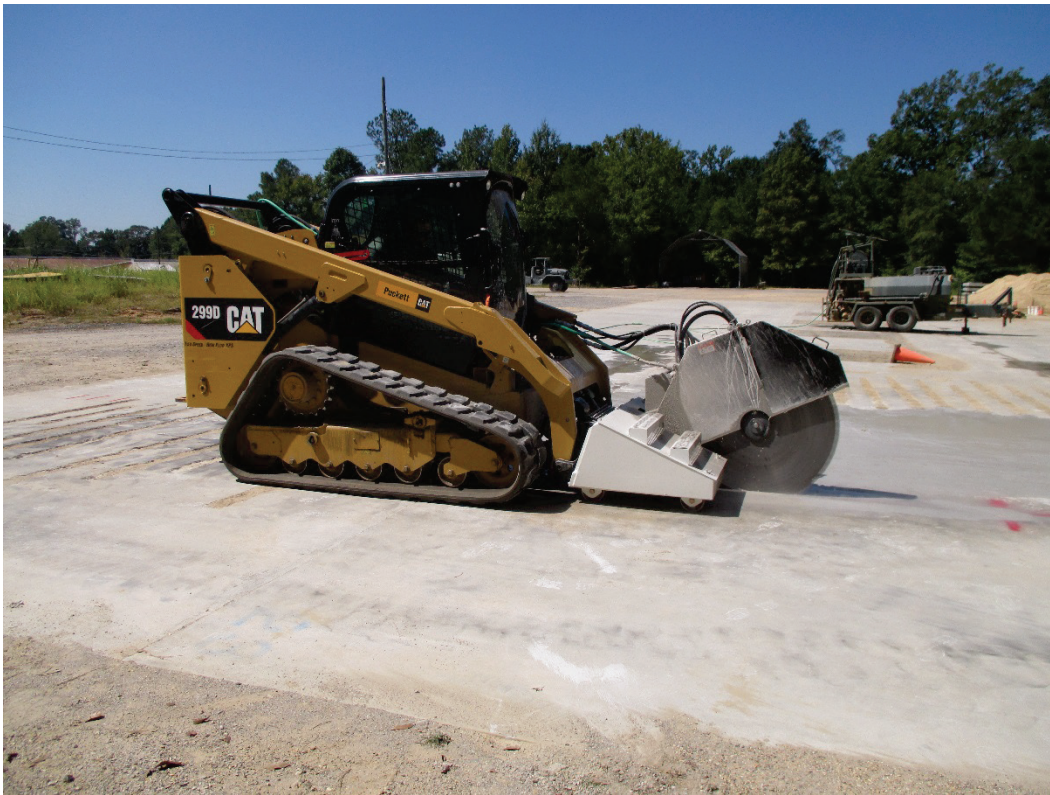
Figure 31. Caterpillar 299D XPS with SS4800HF attachment.

Test 12 included three times cuts using a 42-in.-diam blade with a 0.20-in. width (Figure 31). The initial diamond-tipped depth was approximately 0.49 in. The average precut time was 1 min 27 sec. The three 10- to 13-ft-long cuts ranged from 1.41 to 1.63 ft/min in the 18-in.-thick PCC. The average saw-cutting rate was 1.52 ft/min, which was the same average rate measured with the 42-in.-diam, 0.22-in.-wide diamond saw blade. The height of the diamond tips on the saw blade decreased approximately 18 percent (from 0.49 to 0.42 in.) after 35 ft of cutting through 18-in.-thick PCC.

The modifications made to the diamond-blade skid steer attachment and the ability for the attachment to operate on a CTL in high flow resulted in an average concrete saw-cutting rate almost twice as fast the results from the Evaluation #1 (0.87 ft/min versus 1.52 ft/min). With the limited collected data, it seems as though the thicker 0.22-in.-wide saw blade was more durable than the 0.20-in.-wide blade, although their production rates were the same. Also, saw cutting in the 18-in.-thick concrete used 100 gal of water after approximately 70 linear feet of cutting.
